Chapter 3
Design Examples Appendix Chapter A2
Earthquake Hazard Reduction in Existing
Reinforced Concrete and Reinforced Masonry
Wall Buildings with Flexible Diaphragms

Design Example A2-1 Tilt-up Building Retrofit

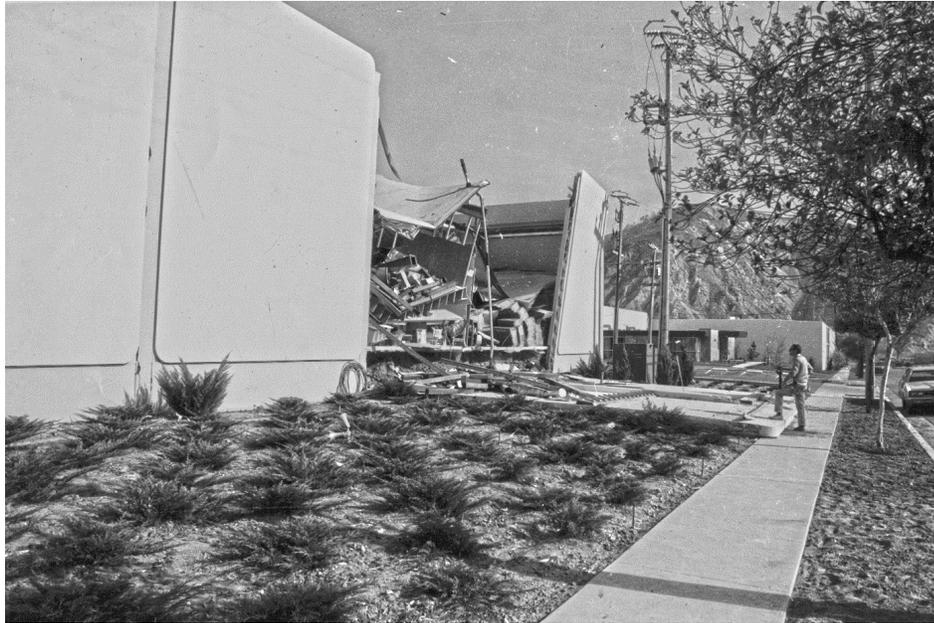
Figure 1. Damage from the 1971 San Fernando Earthquake, Feb 9, 1971
